RIVER MILE 10.9 REMOVAL ACTION CAPPING OPERATIONS WEEKLY STATUS REPORT

Summary of capping operations through week ending April 27, 2014

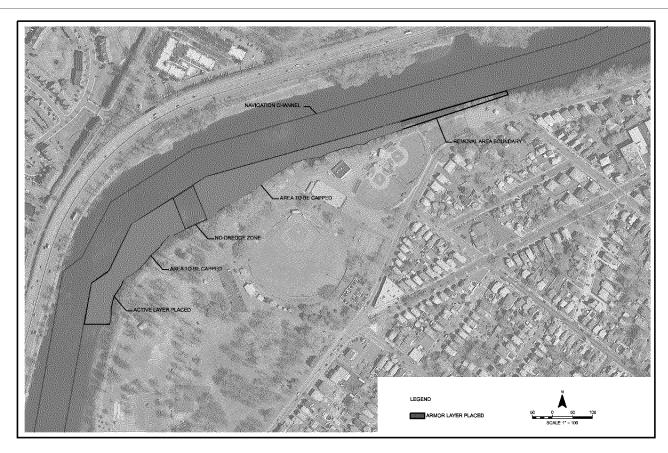
As of April 27, 100% of the dredged and capped area has been protected with a fabric and stone armoring layer. Application of a habitat layer over the armor stone is expected to be completed by mid-May, 2014. The attached figure shows the section of RM 10.9 where the fabric and stone has been placed to date.

Capping Progress to Date Shown in Blue
